Manhole Inspection Summary

Manhole # S39Y1_041MH

Insp Date: **4/8/08 8:37 AM**

Location Address: **3725 5th St.**

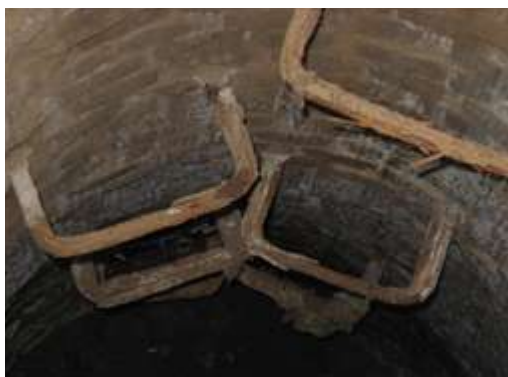
Steps Count: **6** Missing: **0** ☒ **Corroded**

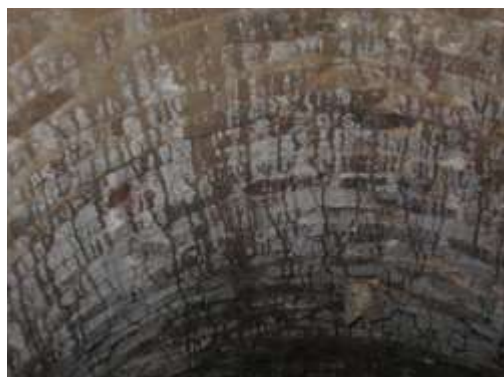
Defect 2

Infiltration: ☐ None ☐ Joint ☐ Cracks ☐ Mortar ☐ Roots ☒ **Wall**

Infiltration

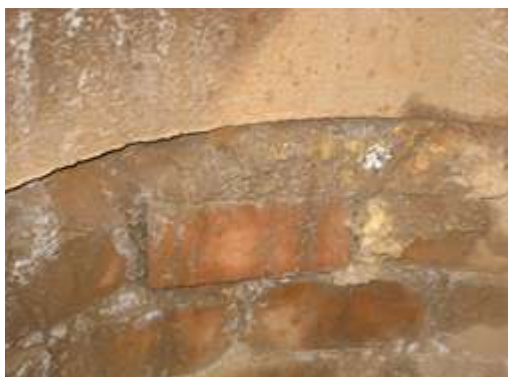
Defect 1

Frame Offset: **1** (in.) Condition: ☒ Sound ☐ Cracked ☐ Leaks

Condition: ☐ Sound ☒ **Cracked** ☐ Root Intrusion ☐ Loose Brick ☐ Deteriorated

Infiltration: ☐ None ☒ **Joint** ☒ **Cracks** ☐ Mortar ☐ Roots ☐ Wall

Frame offset and crack at joint

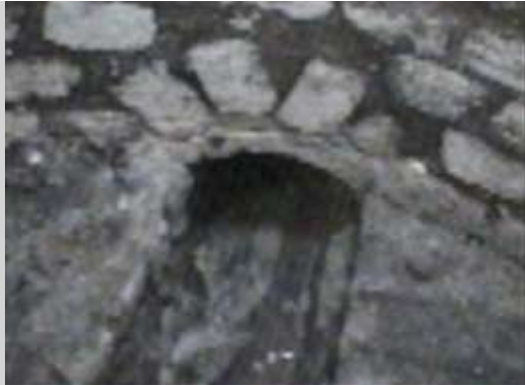
12 O'Clock Outflow

8 in. Circular Gravity Sewer
Pipe Out @ 12 O'Clock

Pipe Height: **8.4** (in.) Rod and Bar (Angled)
Pipe Material: **Clay** ☐ Pipe Lined
Invert Depth: **12.12** (ft.) Flow Characteristics: **Fast**
Deposits: ☒ None ☐ Mud ☐ Sludge ☐ Debris ☐ Grease
Silt Depth: (in.) Deposits Extent:
Infiltration: **None** Pipe Seal Cond: **Sound**

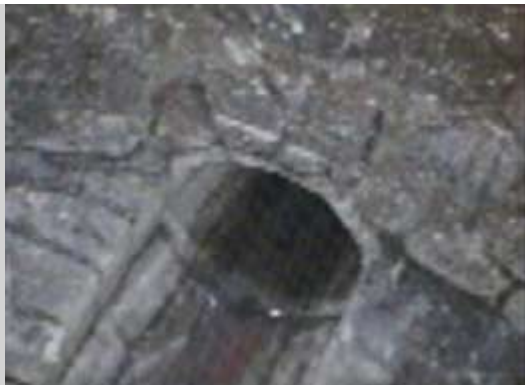
9 O'Clock Inflow

8 in. Circular Gravity Sewer
Pipe In @ 9 O'Clock

Pipe Height: **7.2** (in.) Rod and Bar (Angled)
Pipe Material: **Clay** ☐ Pipe Lined
Invert Depth: **11.90** (ft.) Flow Characteristics: **Fast**
Deposits: ☒ None ☐ Mud ☐ Sludge ☐ Debris ☐ Grease
Silt Depth: (in.) Deposits Extent:
Infiltration: **None** Pipe Seal Cond: **Sound**
